CHARLES RIVER BASIN
HOLLISTON, MASSACHUSETTS

HOUGHTON POND DAM
MA 00444

PHASE I INSPECTION REPORT
NATIONAL DAM INSPECTION PROGRAM

JULY 1979

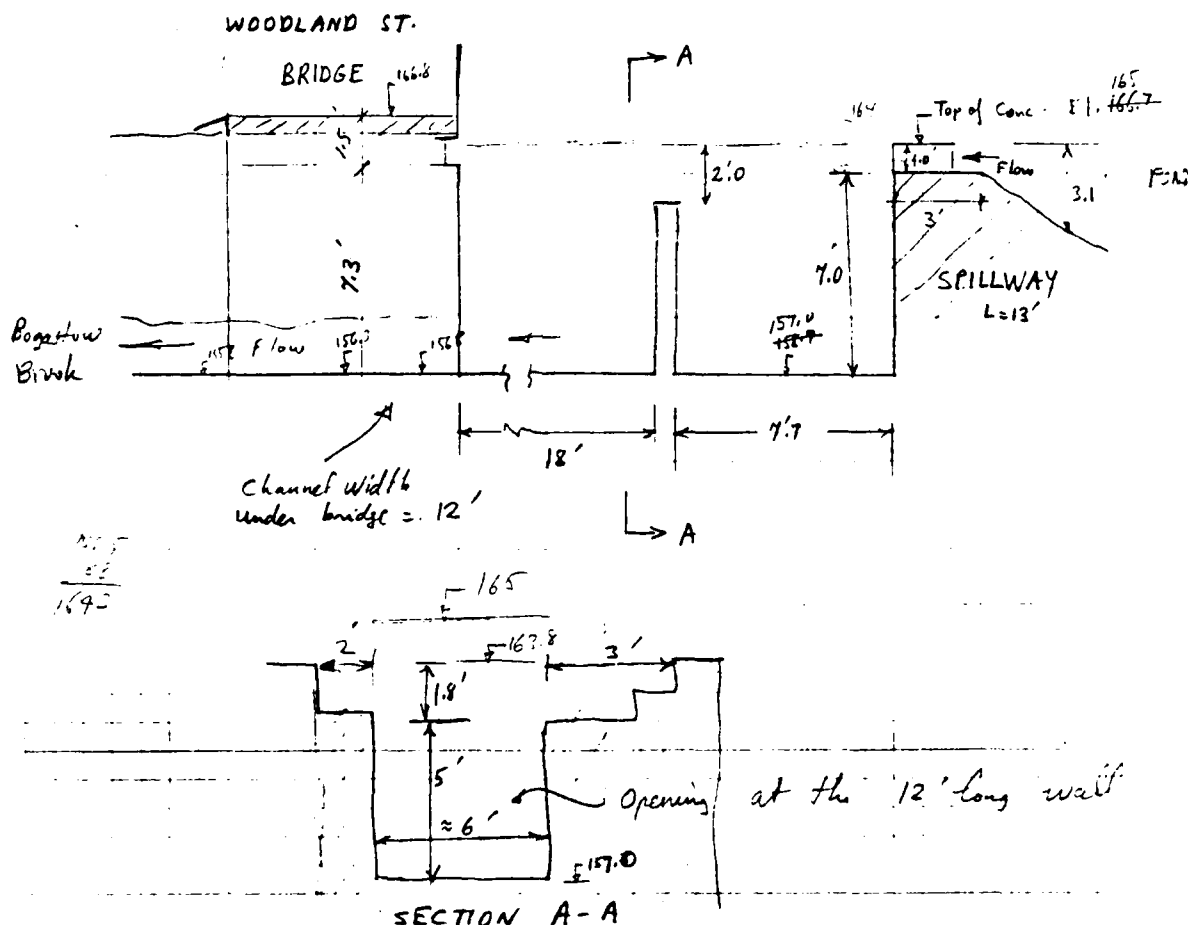
SECTION THROUGH FACTORY POND OUTLET & WOODLAND STREET BRIDGE

An old road exist on downstr side of the Woodland Str. Bridge. This old road was collapsed and dislocated; its surface hanging into the channel 3.3' below the surface of the Woodland St.
